Contract #: 04-0120F4Cty: SF/ALA Rte: 80 PM: 13.2/13.9File #: 69.28**WELDING INSPECTION REPORT****Resident Engineer:**Pursell, Gary**Address:** 333 Burma Road**City:** Oakland, CA 94607**Report No:** WIR-007653**Date Inspected:** 30-Jun-2009**Project Name:** SAS Superstructure**OSM Arrival Time:** 700**Prime Contractor:** American Bridge/Fluor Enterprises, a JV**OSM Departure Time:** 1900**Contractor:** Zhenhua Port Machinery Company, Ltd (ZPMC), Changxing Island **Location:** Shanghai, China**CWI Name:** Wu Zhi Cheng**CWI Present:** Yes No**Inspected CWI report:** Yes No N/A**Rod Oven in Use:** Yes No N/A**Electrode to specification:** Yes No N/A**Weld Procedures Followed:** Yes No N/A**Qualified Welders:** Yes No N/A**Verified Joint Fit-up:** Yes No N/A**Approved Drawings:** Yes No N/A**Approved WPS:** Yes No N/A**Delayed / Cancelled:** Yes No N/A**Bridge No:** 34-0006**Component:** OBG Segments**Summary of Items Observed:**

Segment 4BE

Segment 1BW

WELDING INSPECTION REPORT

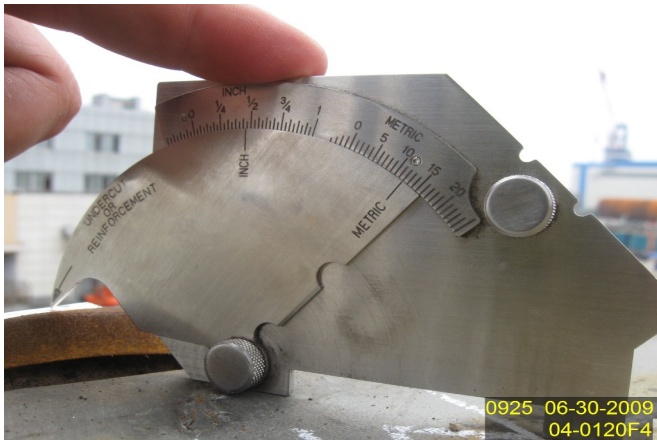
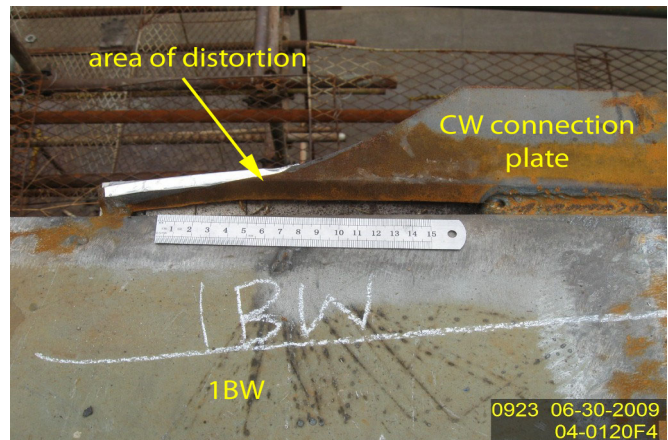
This QA Inspector observed the Counter Weight (CW) Connection plate at weld joint OBW1A-013 was distorted during welding of the CJP joint at the tapered end. The connection plate is distorted for approximately 200 mm in length and 12mm offset from face of the Deck Plate and CW connection plate.
